# Walk Around

## Focke-Wulf Fw 190A/F

Walk Around Number 22  
squadron/signal publications

By Malcolm Laing and E. Brown Ryle

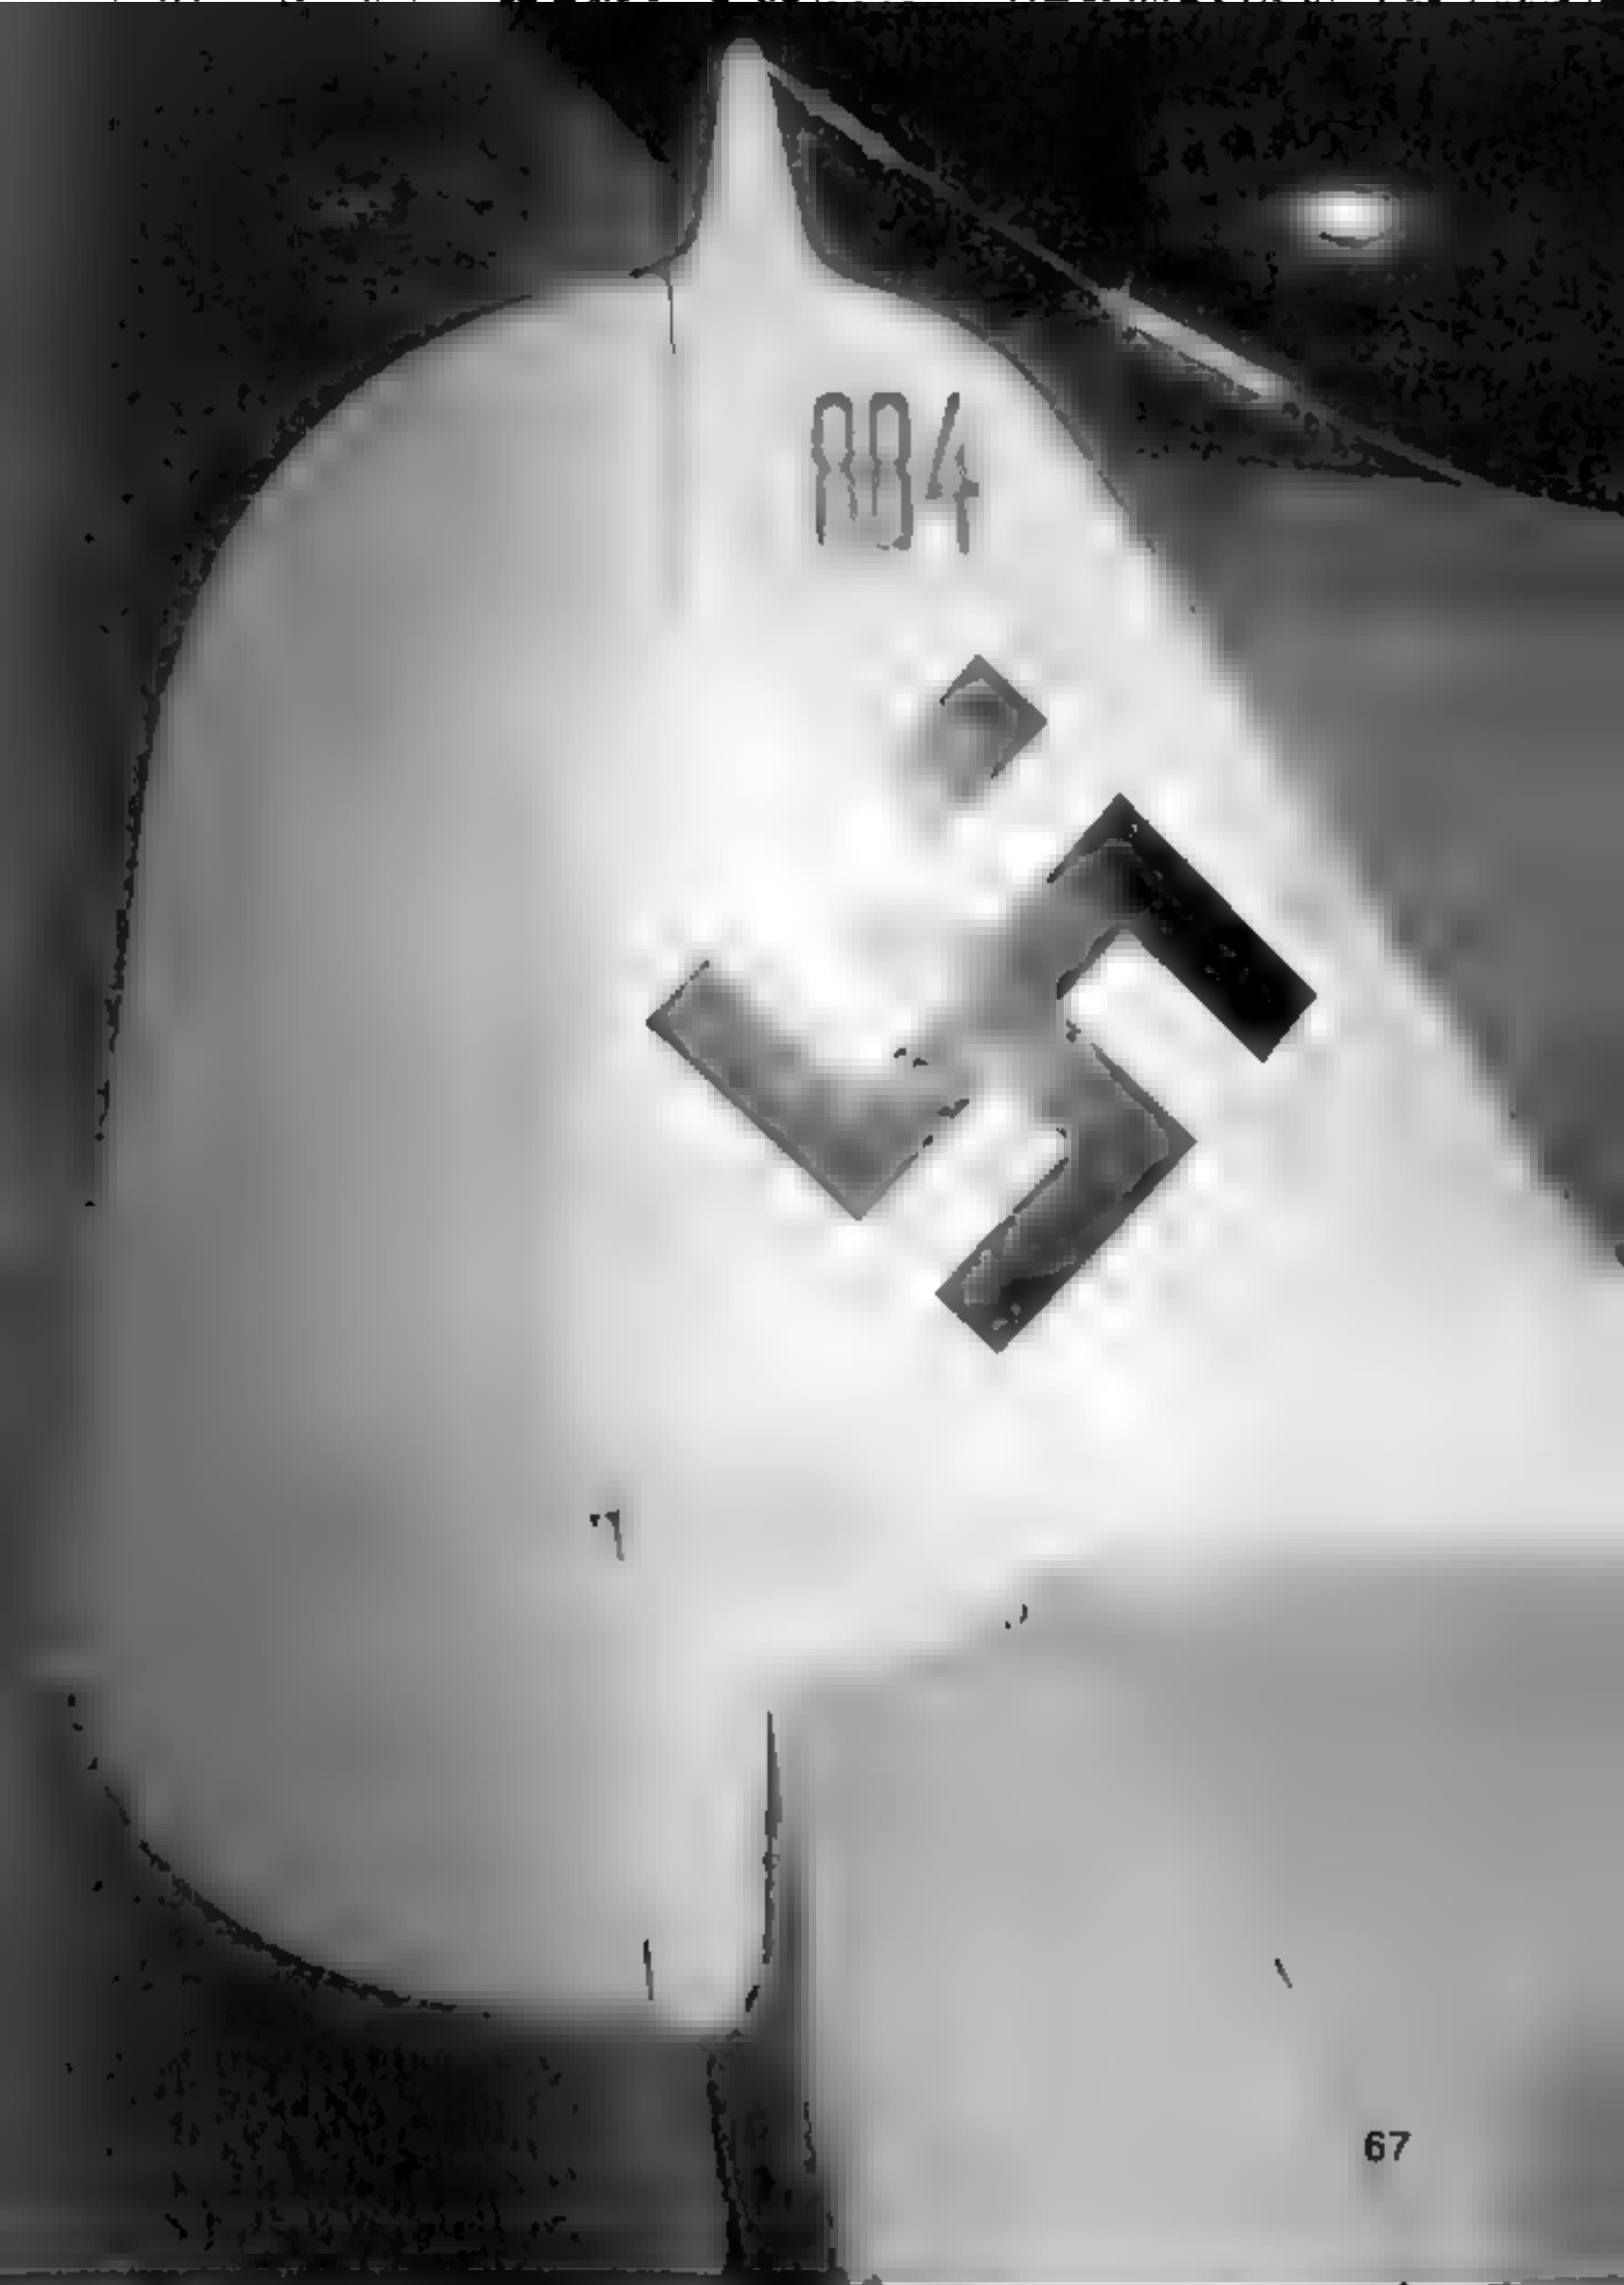
(Right) The Fw 190F-8 tail assembly was virtually unchanged on radial engined Fw 190s throughout the war. The tall antenna mast replaced the shorter antenna housing on the Fw 190A-4. The rudder was attached to the vertical stabilizer by three pivot bearings, although held in place by small bolts at the center point/actuation lever. The light colored section of the main antenna wire is a ceramic insulator. Only the last three numbers of the W Nr (Werk Nummer, Factory Number) were painted in black on the starboard side of the stabilizer – a common practice in the Luftwaffe. (Mautner)

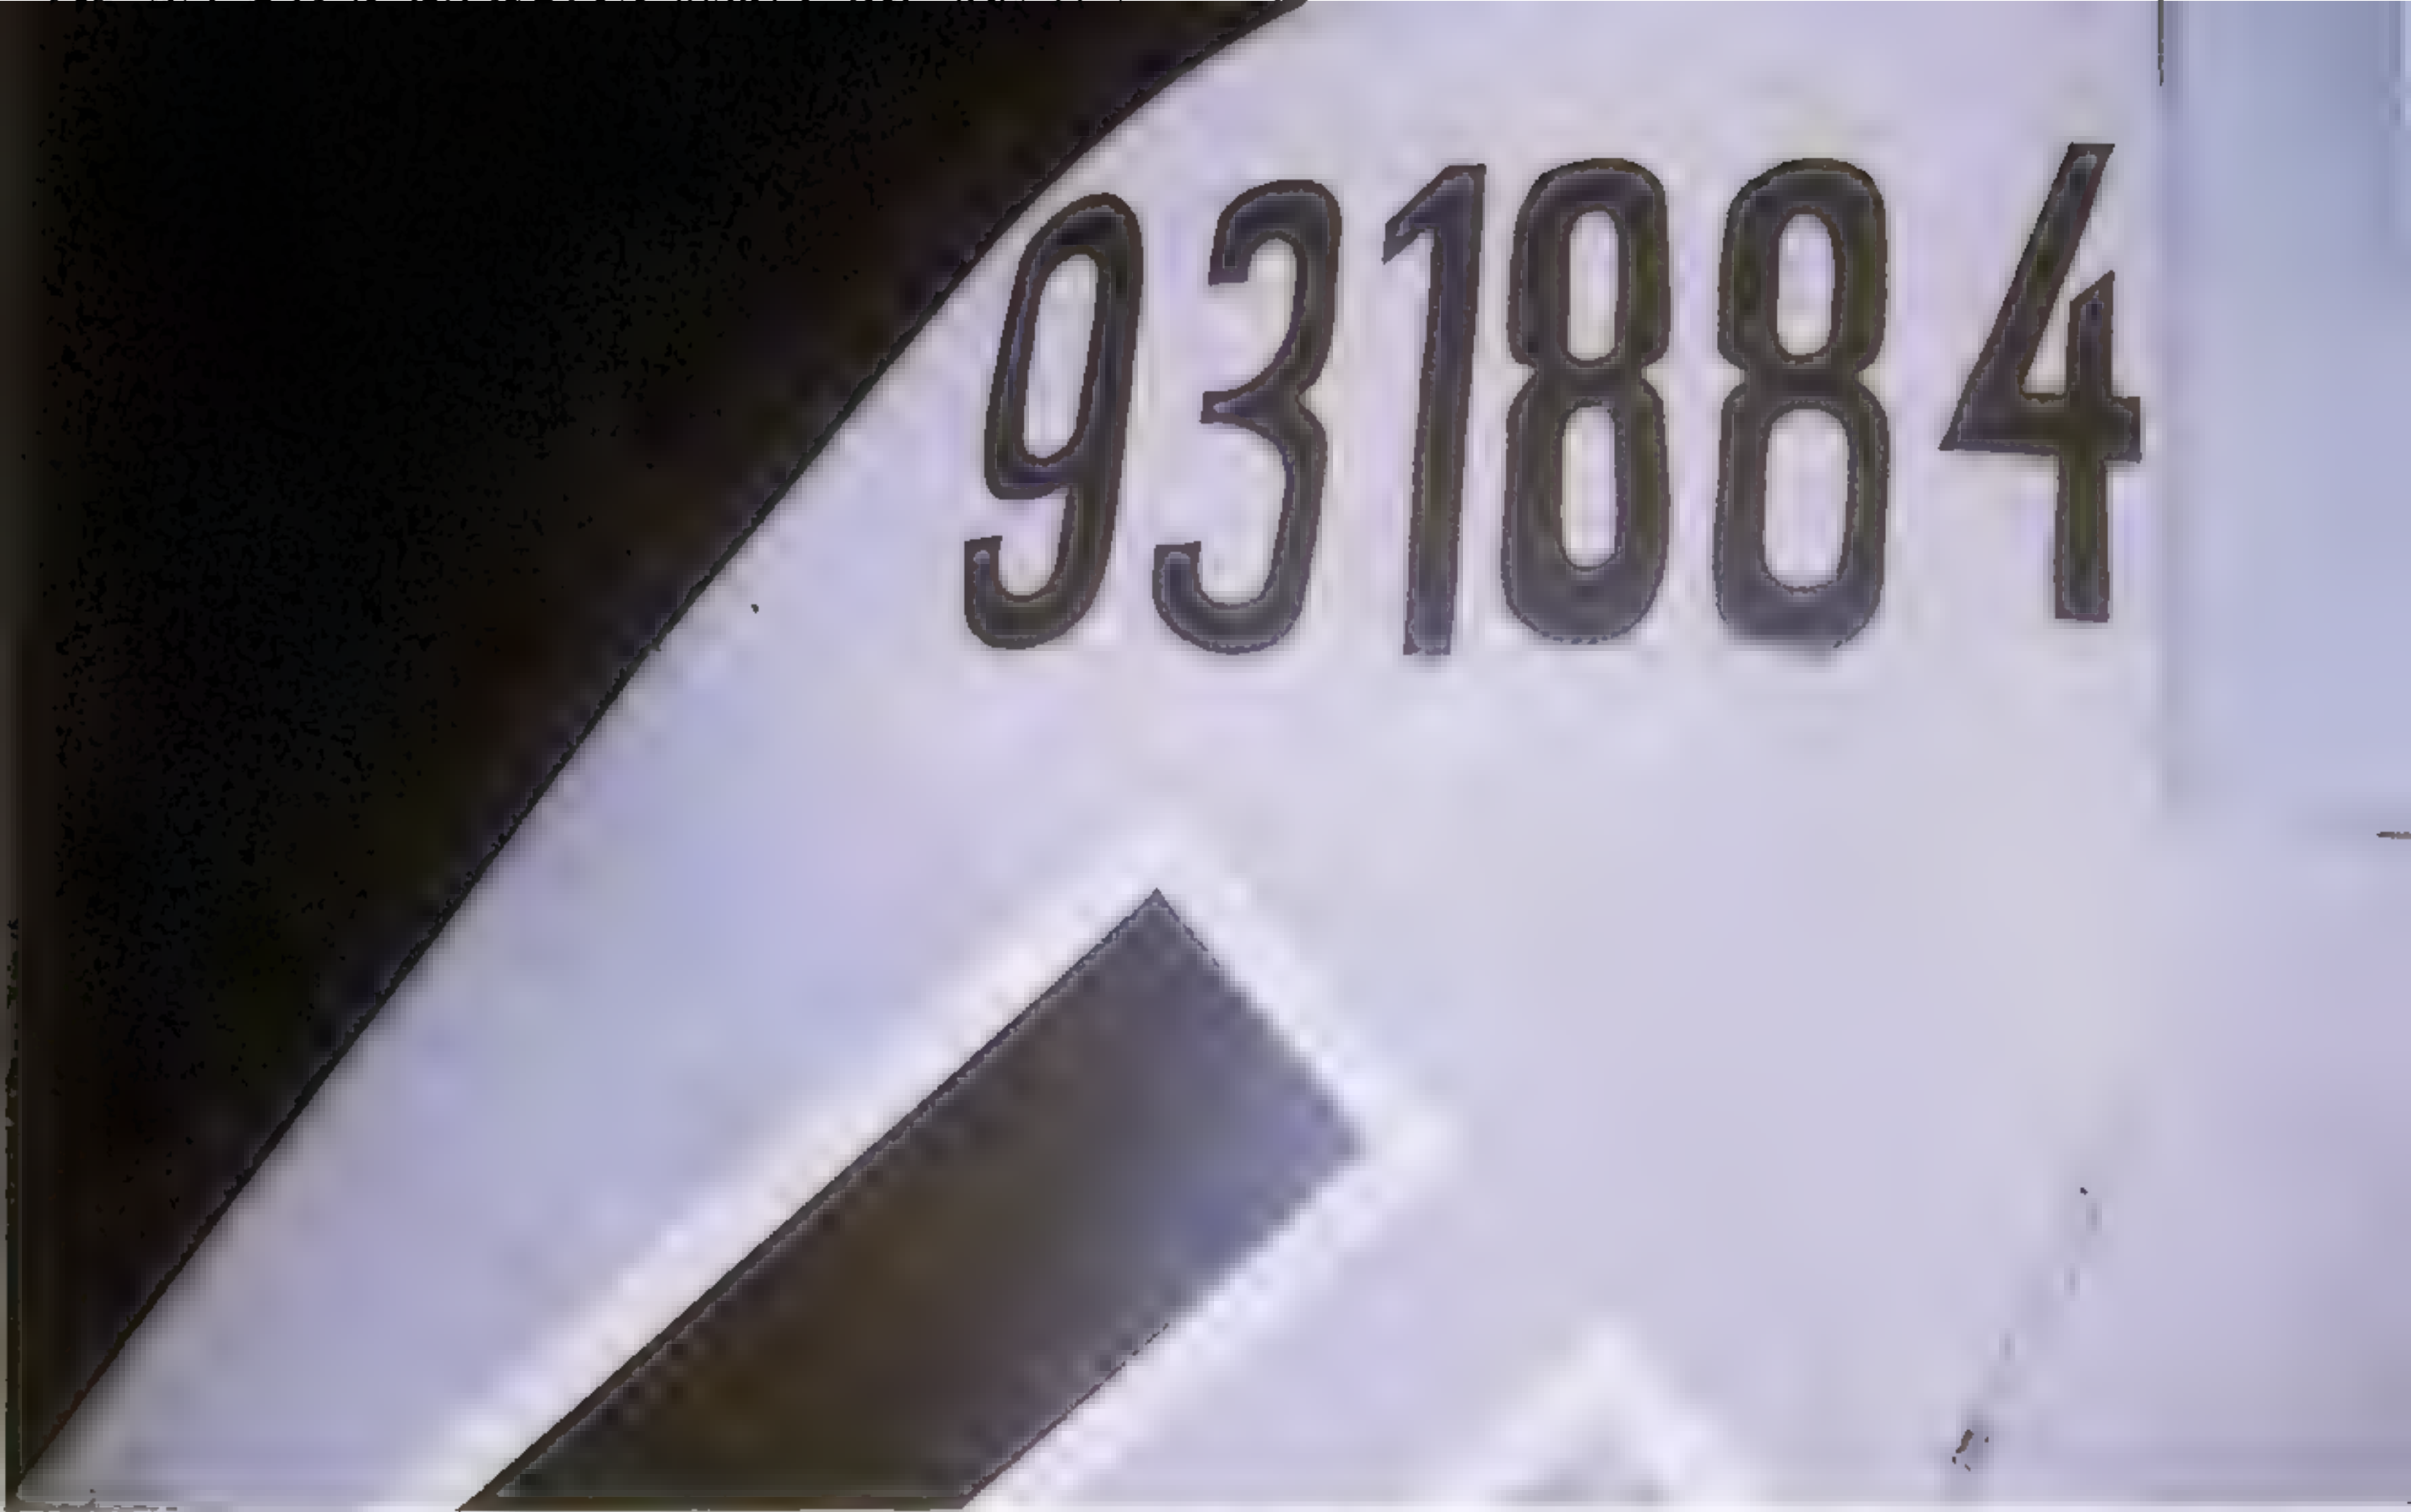
The full *Werk Nummer* (Factory Number) of this Fw 190F-8 is painted on the port vertical stabilizer. The position of the hand-painted number – at the top of the stabilizer – was the most common location of this item on Fw 190s. The top of the tail wheel strut access door is located just below the upper portion of the rudder. (Ryle)

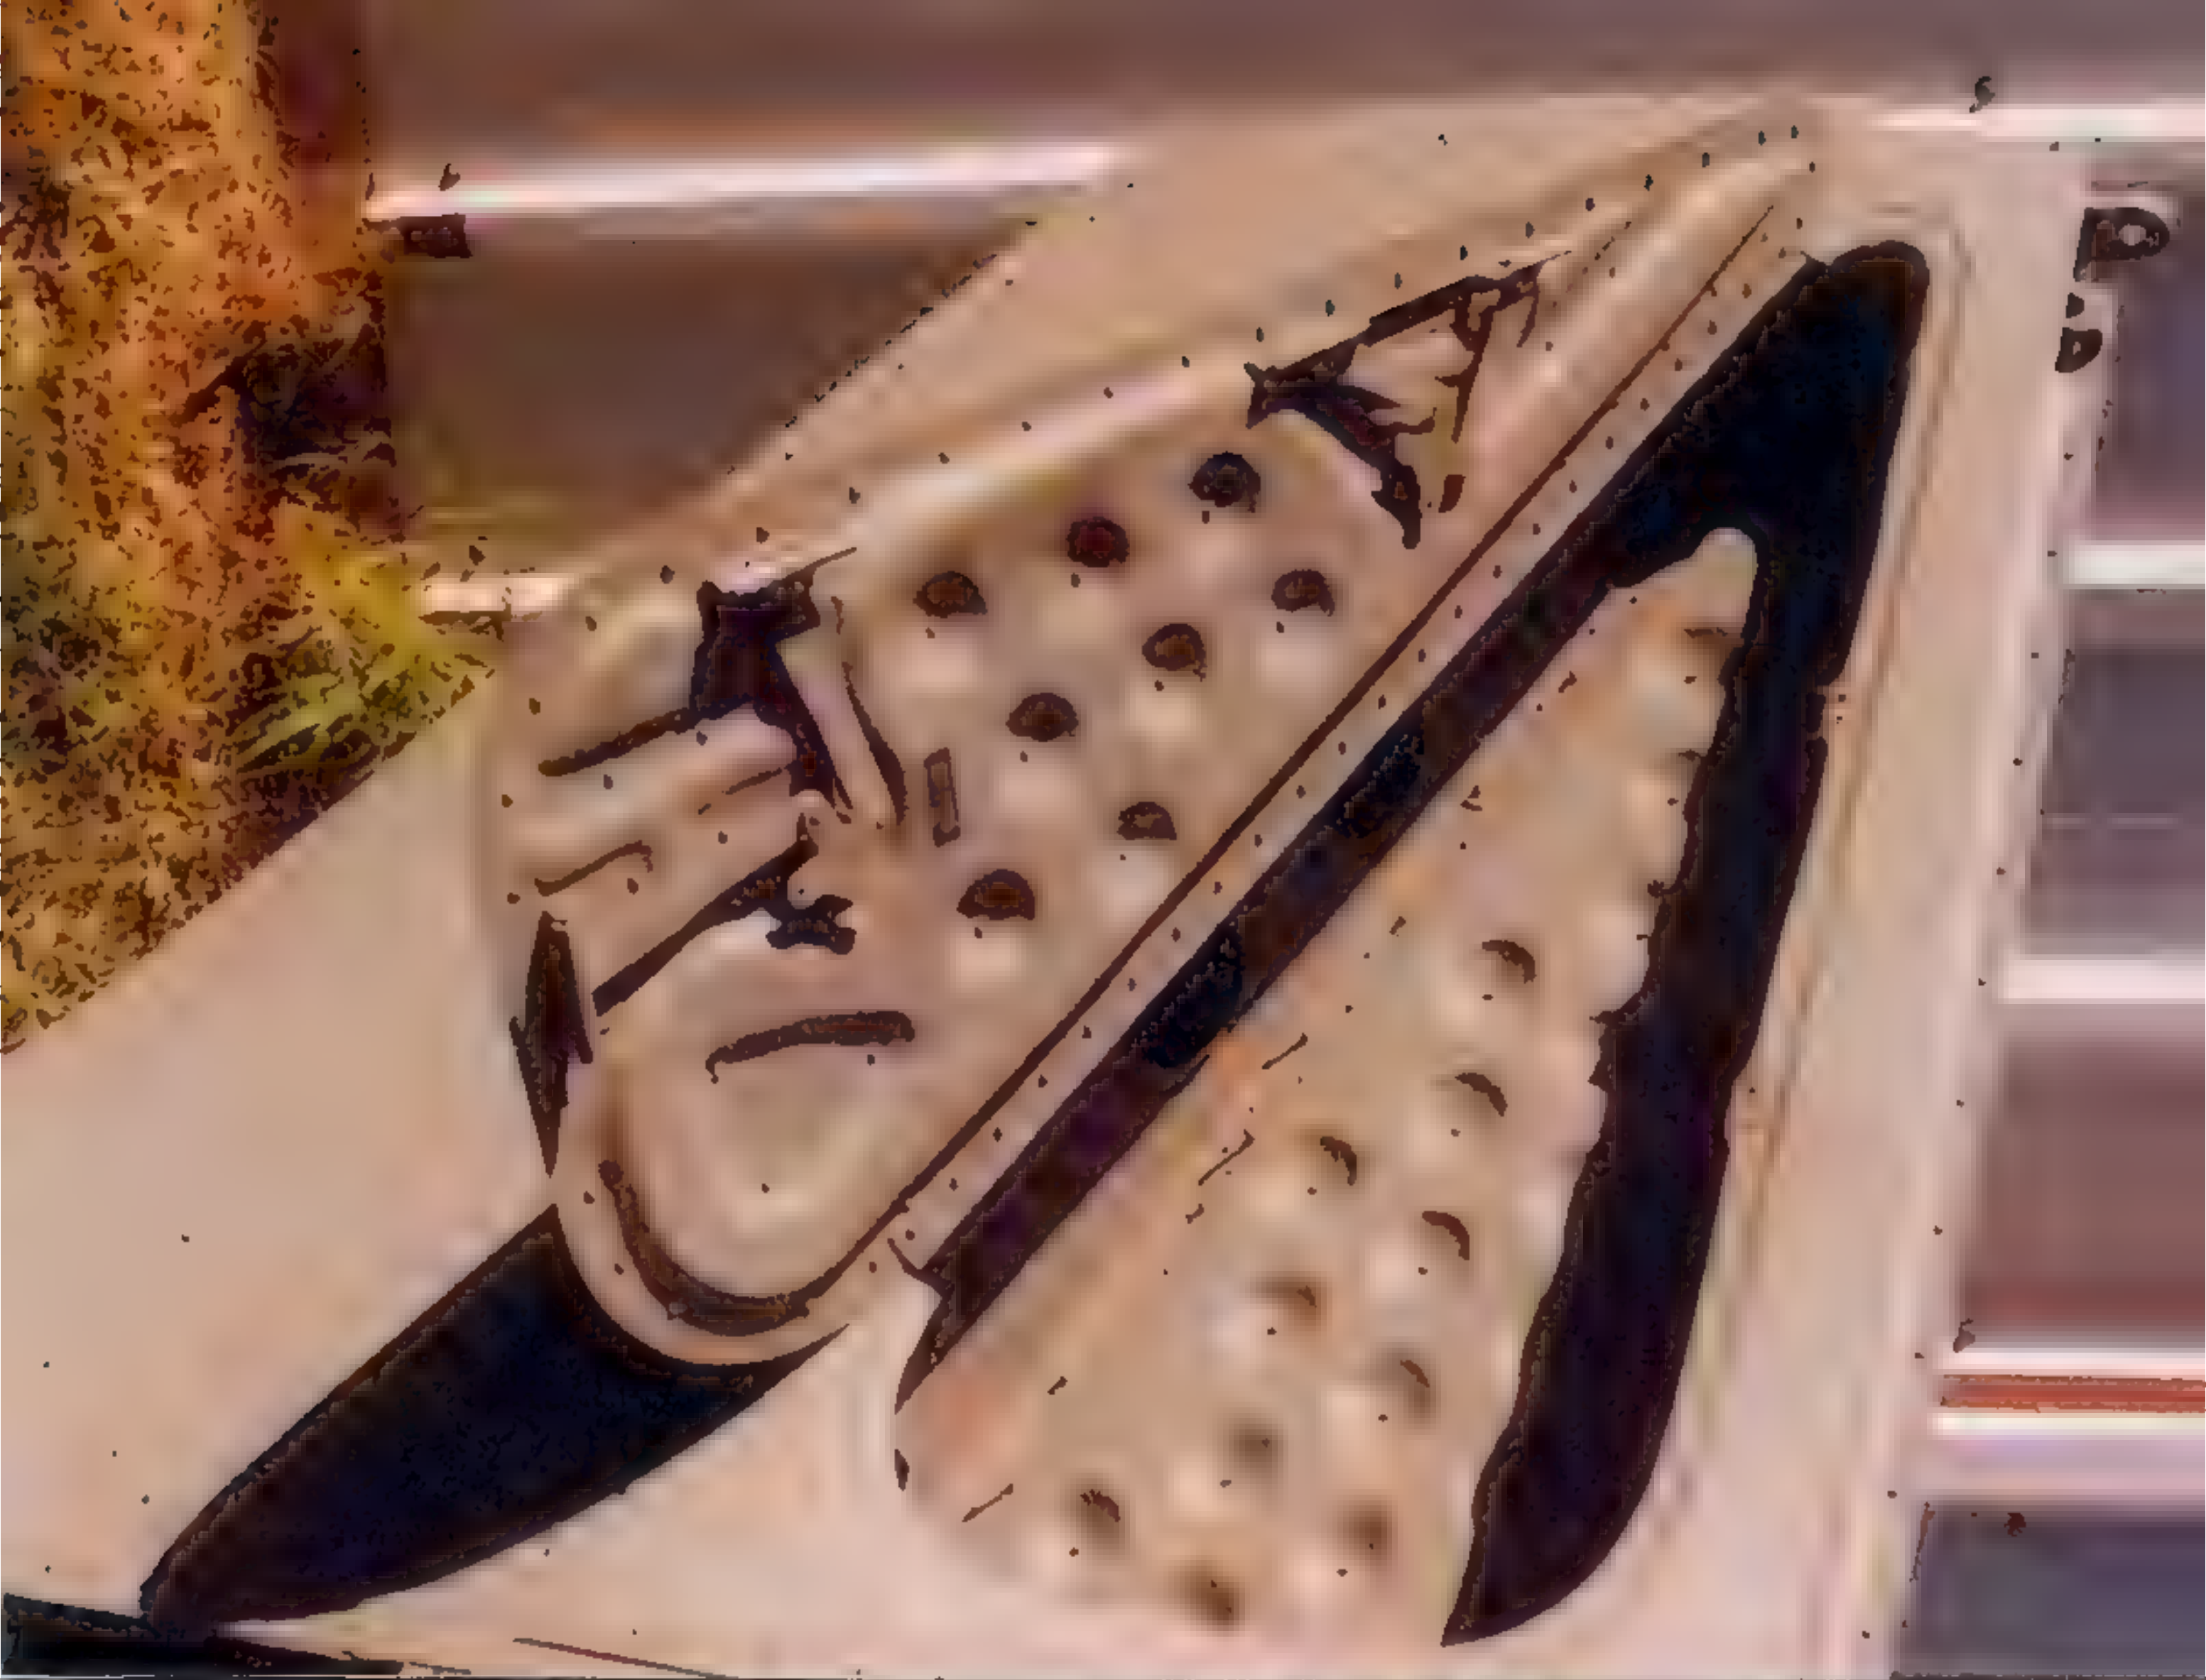
The tail wheel strut access door is open on an Fw 190 vertical stabilizer under restoration at Rio Hondo, Texas. The waffle pattern stiffening panels on the tail inner surfaces were common to all Fw 190s. Two door locking mechanisms were installed to secure the door closed for flight. A decal data tag was applied above the lower lock. (Houston)

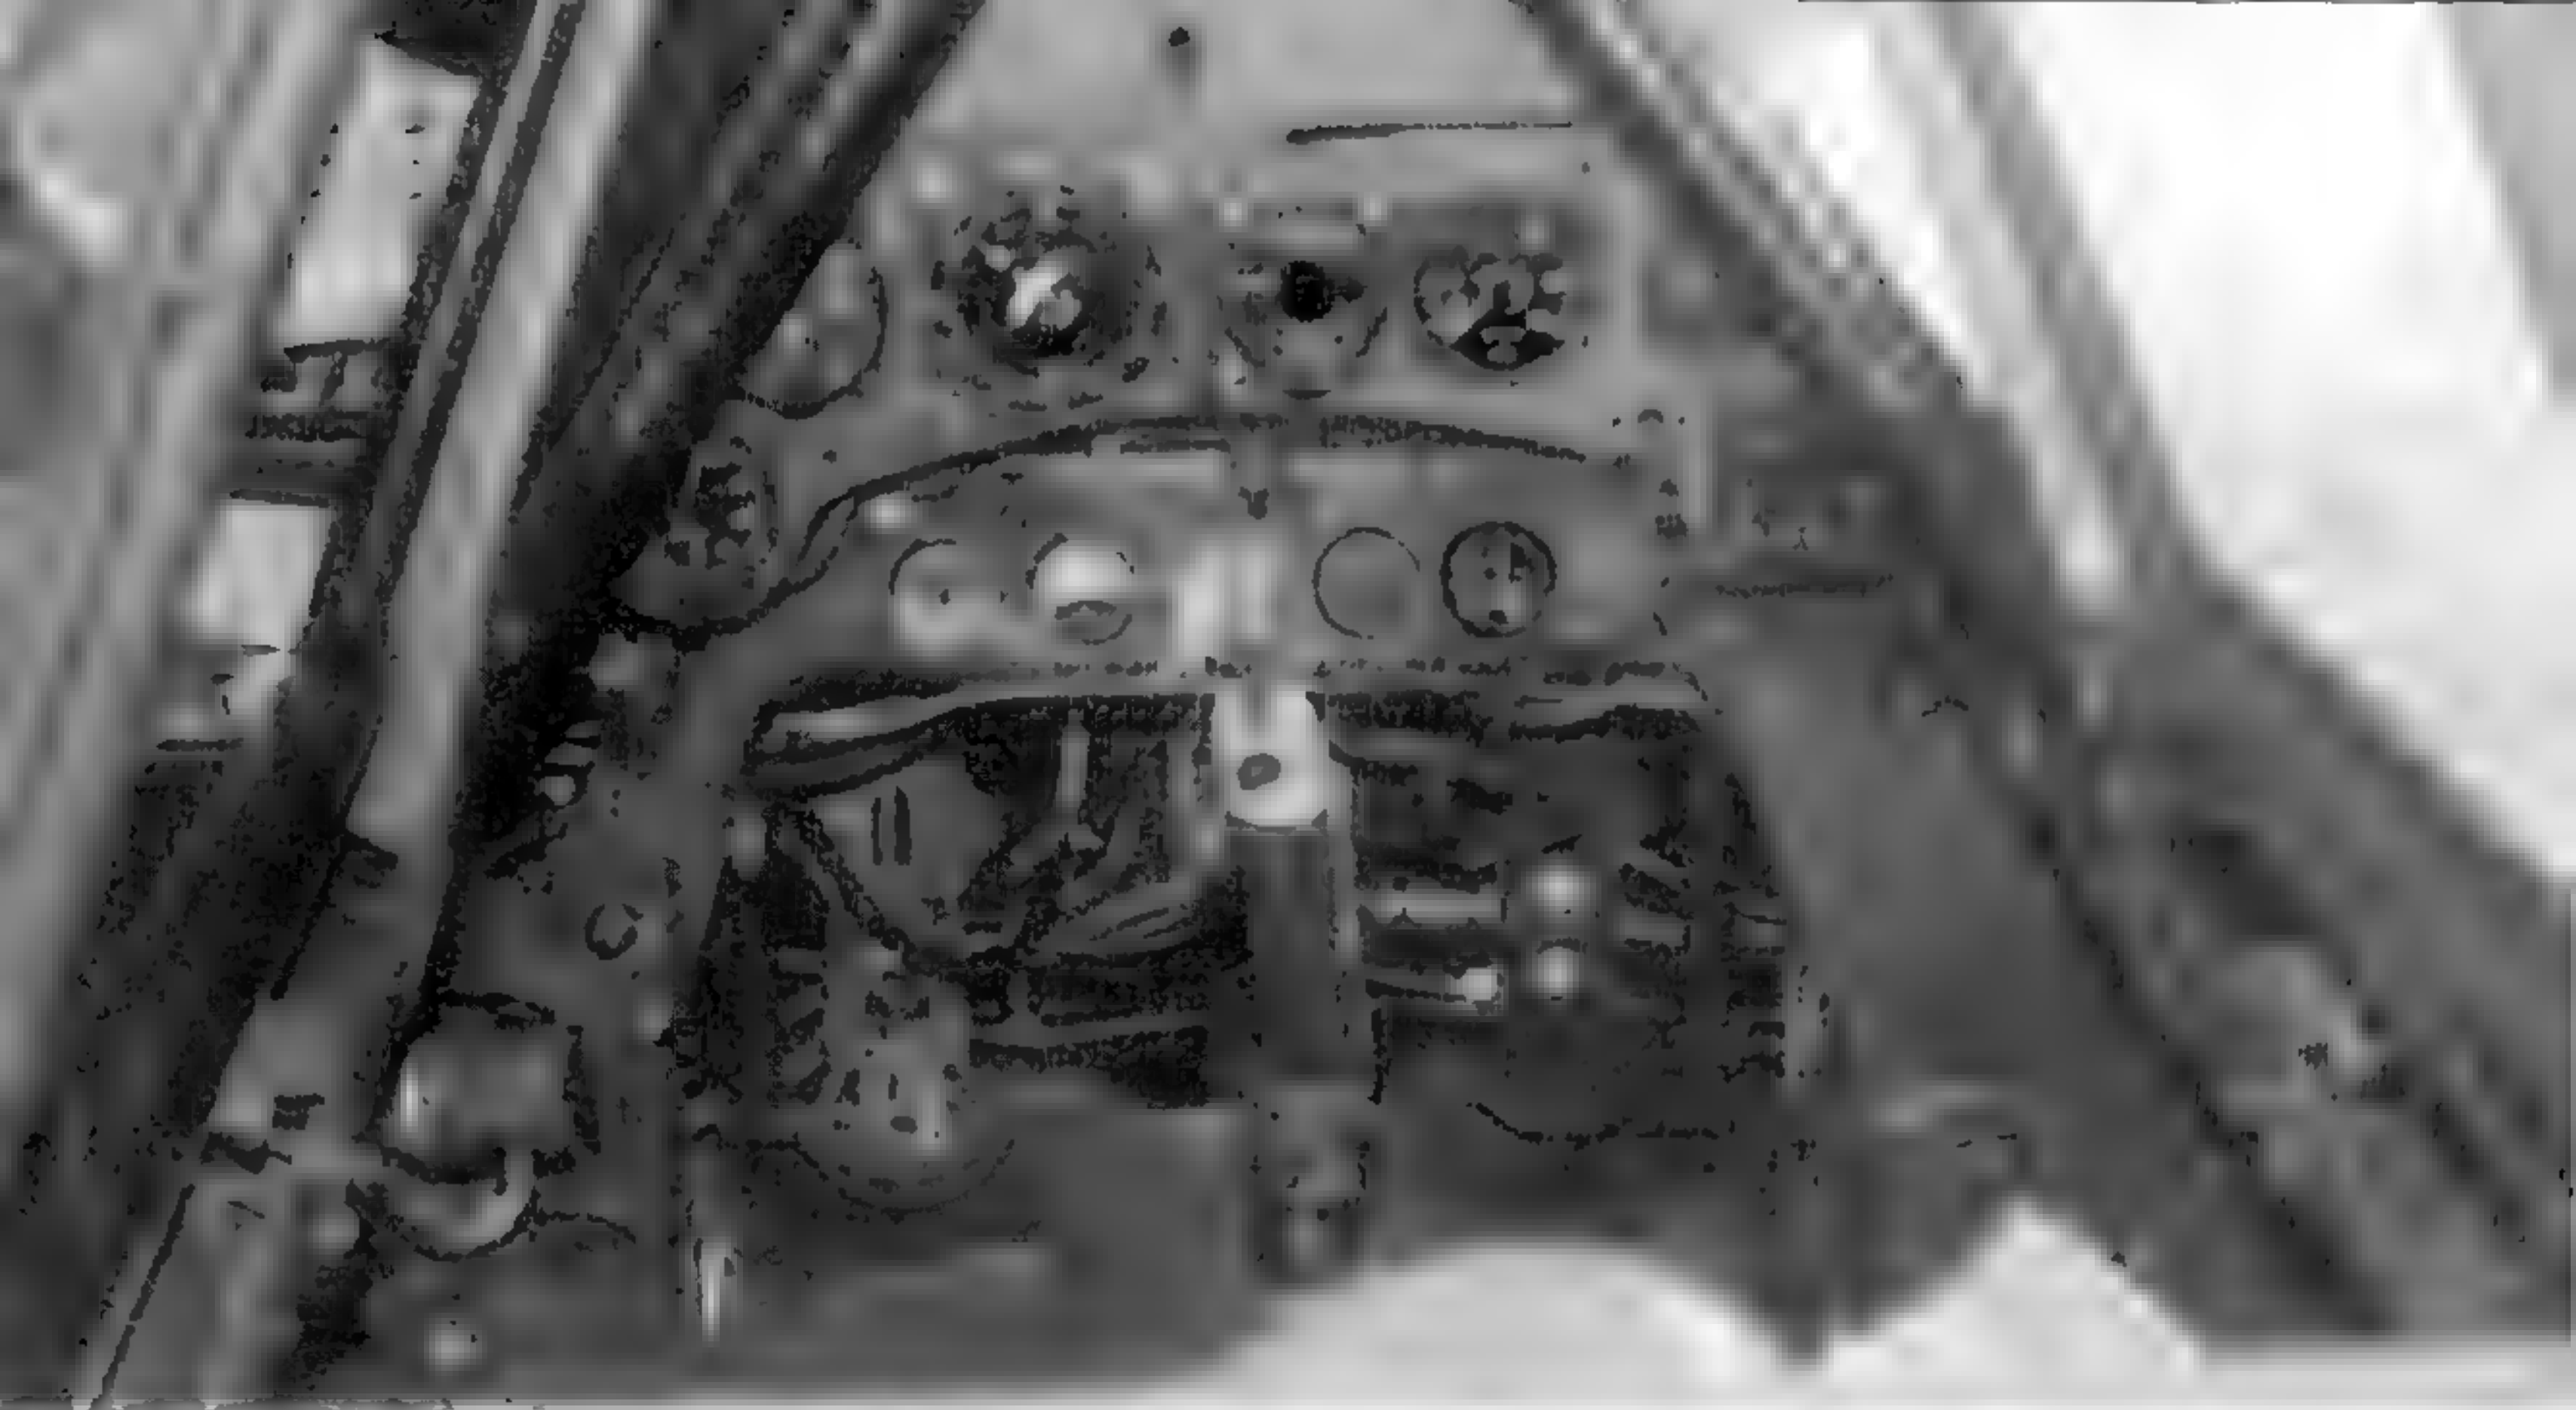
The Fw 190S-8 forward cockpit is much like a standard late war Fw 190 cockpit; however, a few items are different. The two-seater lacks a gun sight, advanced navigation equipment, weapon round counters, and the oxygen system. The handful of two-seat Fw 190Ss produced served as conversion trainers with ground attack units operating the Fw 190F and G and in Luftwaffe advanced flight schools. (Ranger)

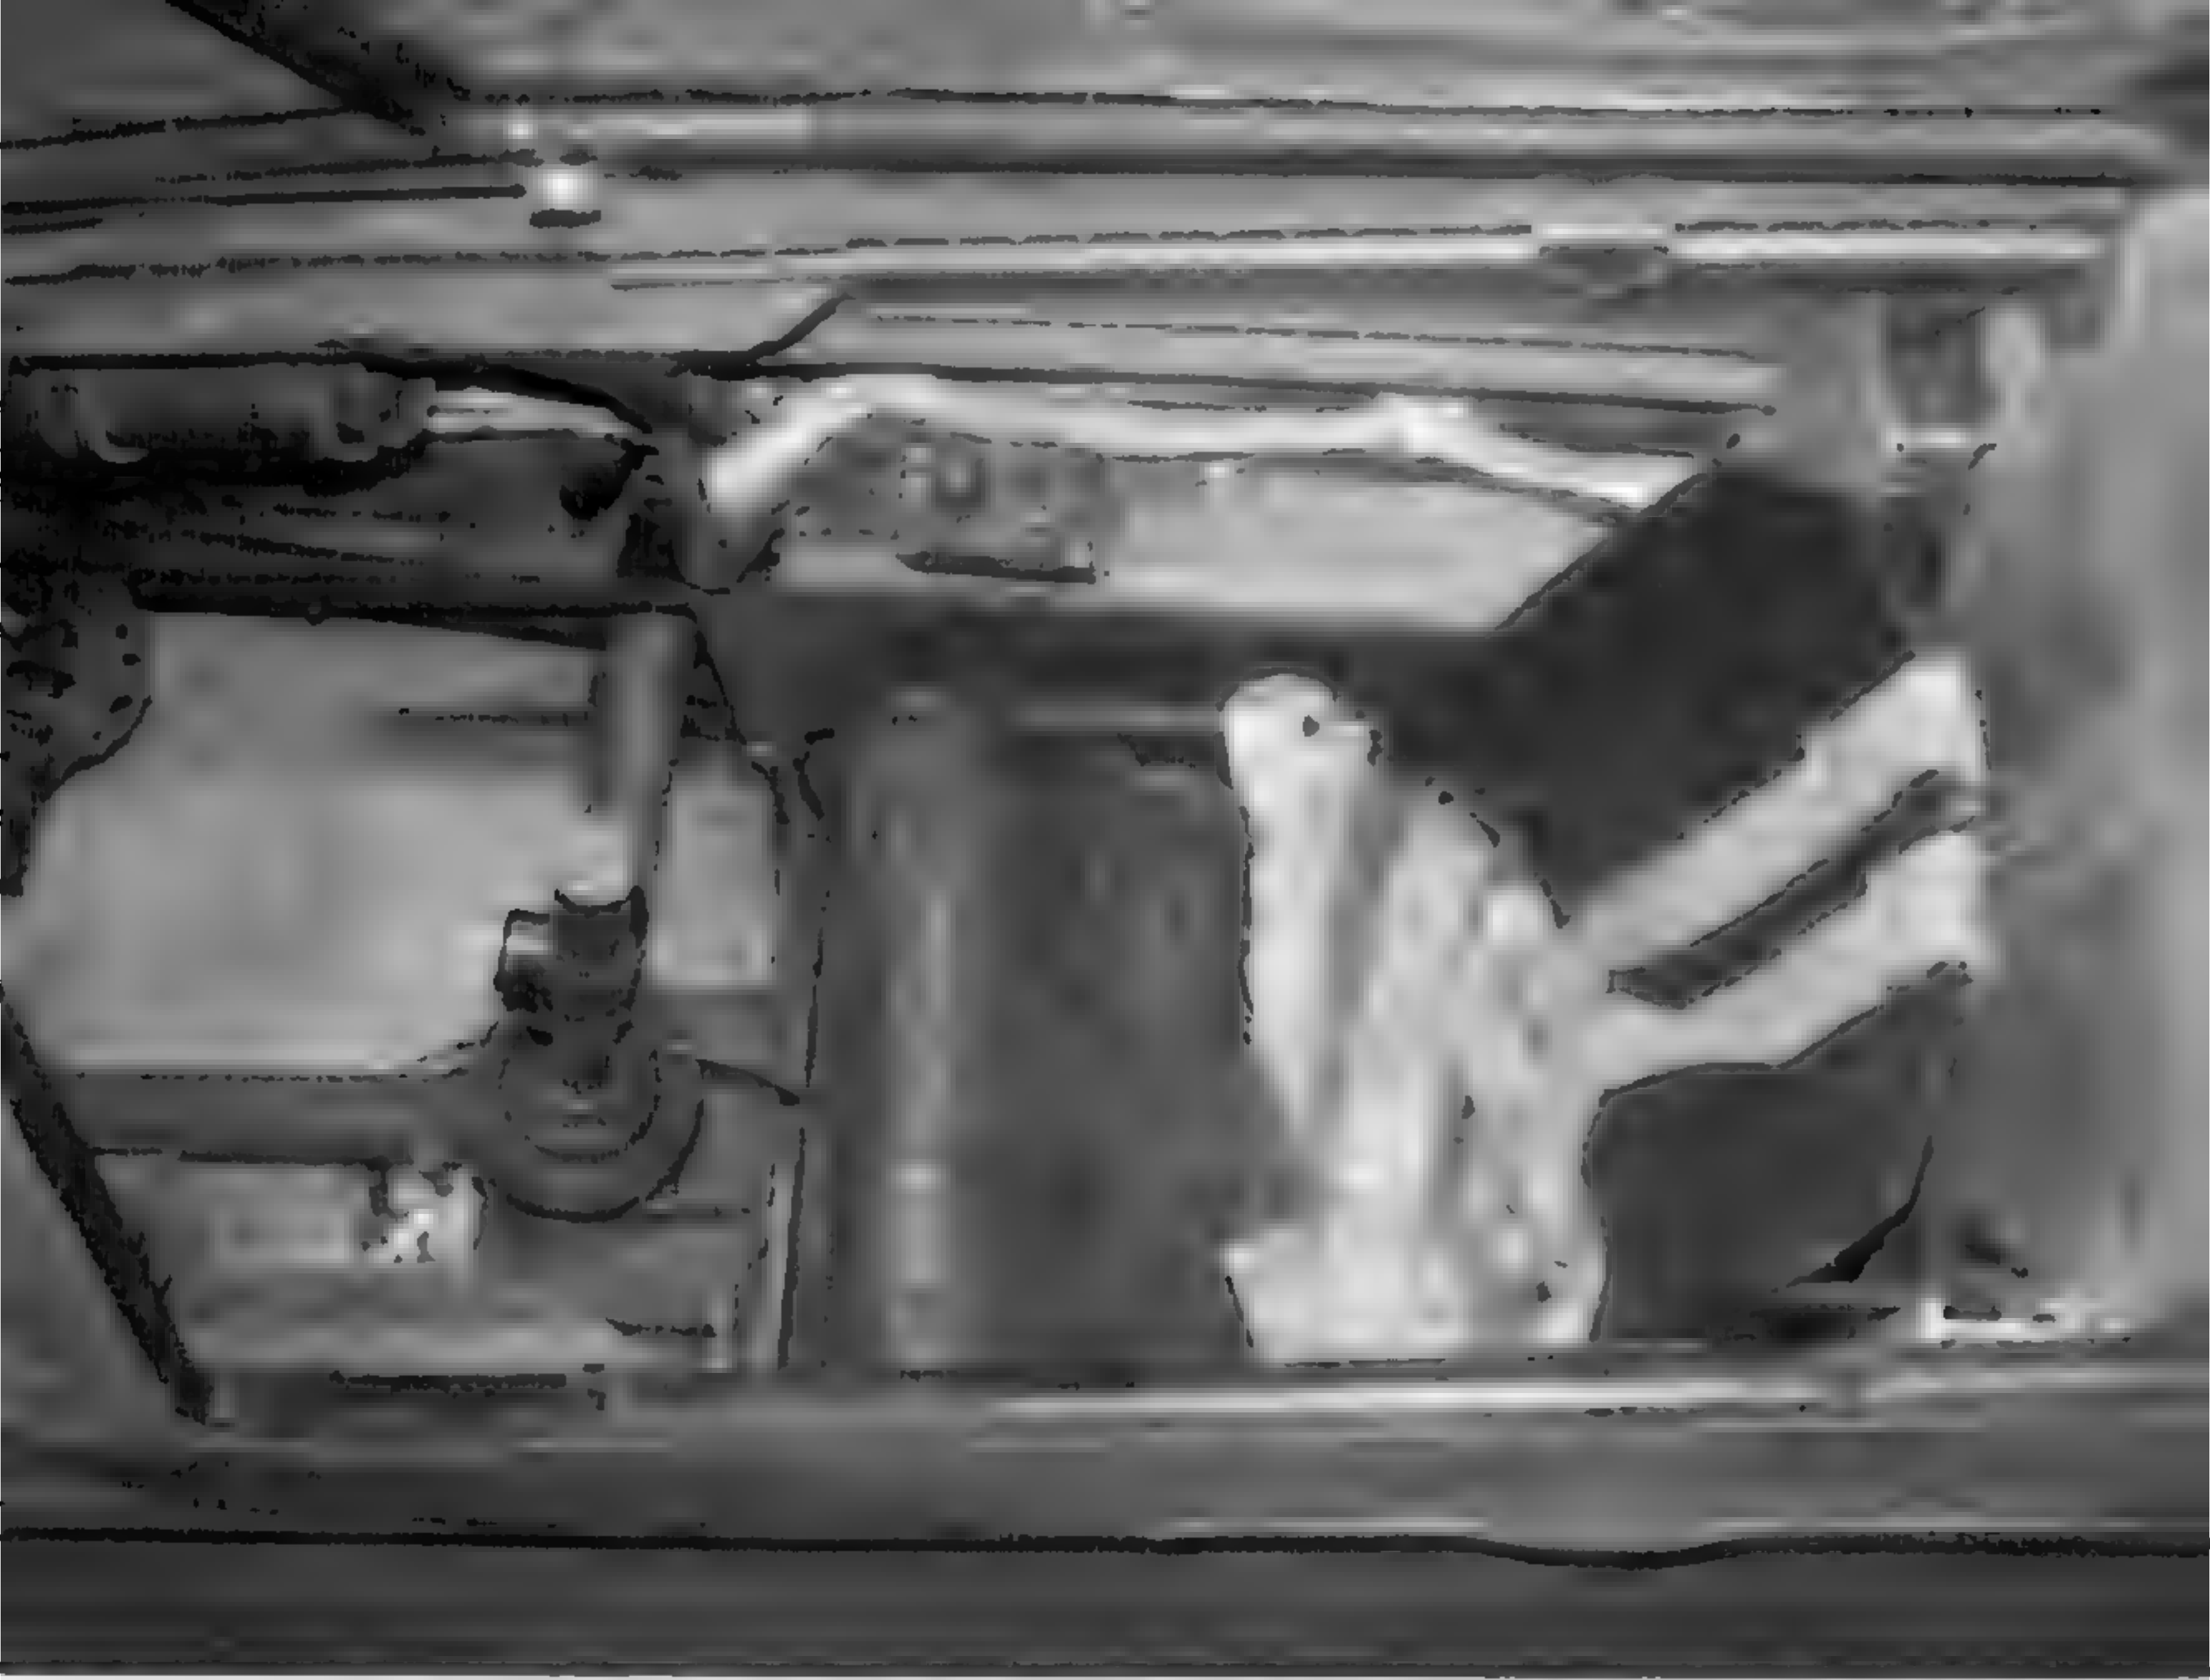
The instructor occupied the aft cockpit of the Fw 190S-8. The aft cockpit was built into the fuselage by extending the canopy into two sections and extending the cockpit aft to install the second crew station. The canvas seat belts are white, with the shoulder straps attached to a steel bar immediately aft of the seat back. A brown leather seat cushion is installed, while the control stick has a wooden grip. (Ranger)

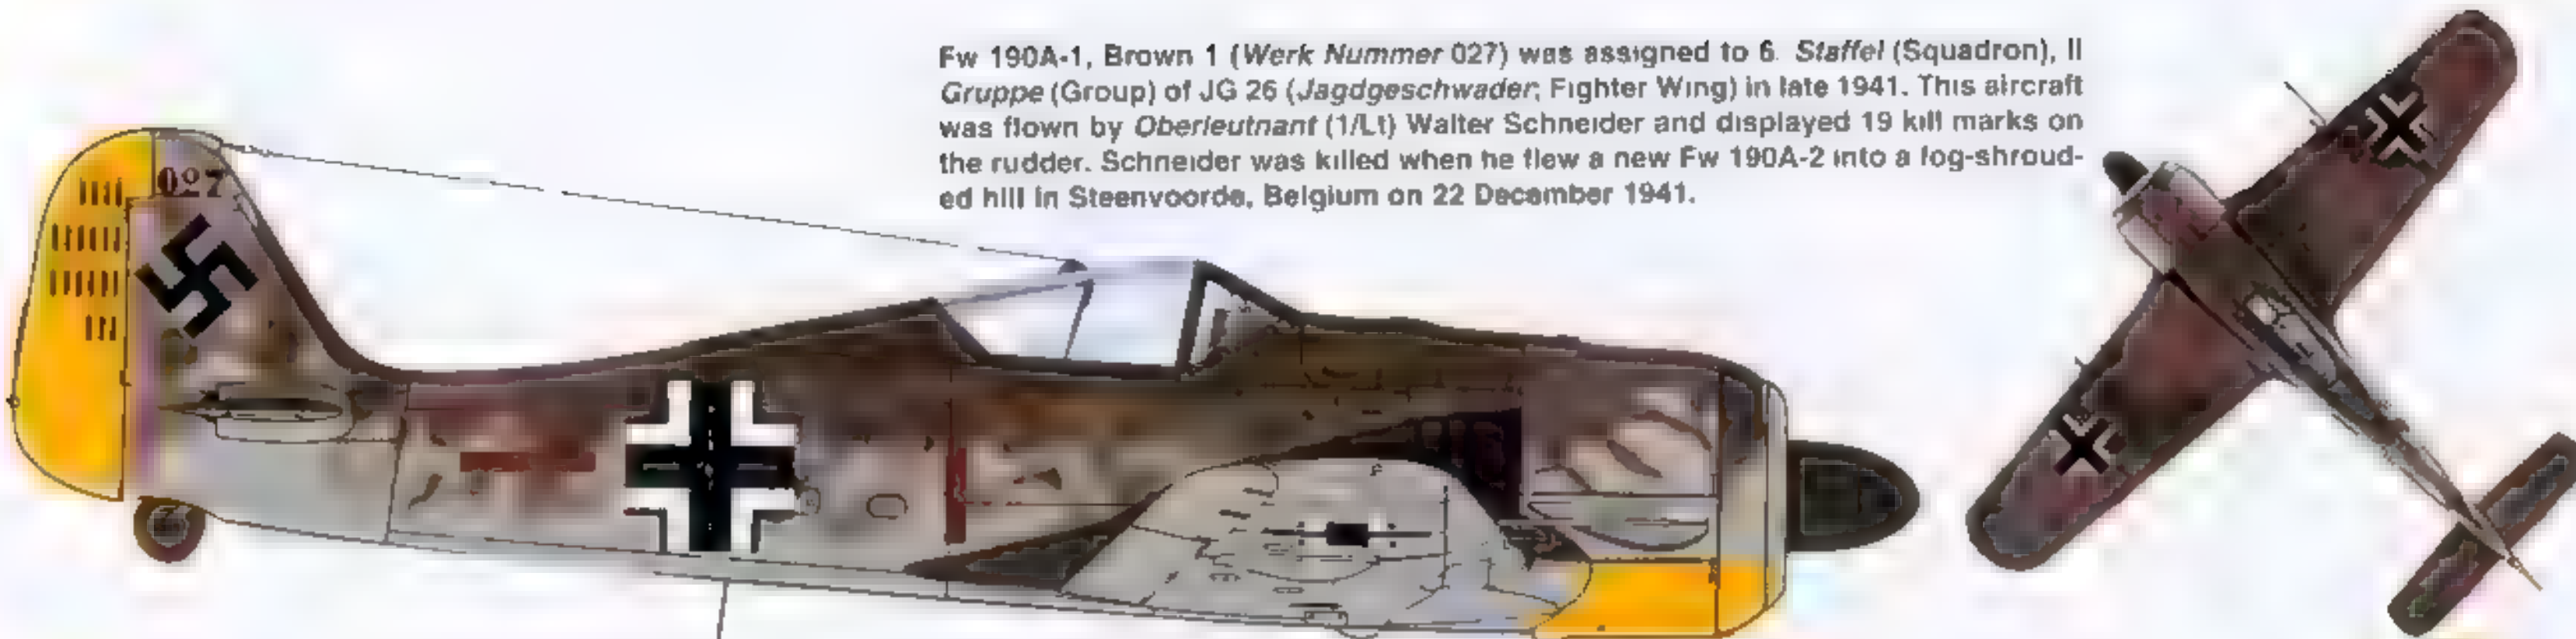
Fw 190A-1, Brown 1 (Werk Nummer 027) was assigned to 6. Staffel (Squadron), II Gruppe (Group) of JG 26 (Jagdgeschwader, Fighter Wing) in late 1941. This aircraft was flown by Oberleutnant (1/Lt) Walter Schneider and displayed 19 kill marks on the rudder. Schneider was killed when he flew a new Fw 190A-2 into a fog-shrouded hill in Steenvoorde, Belgium on 22 December 1941.
